NATIONAL PROGRAM FOR INSPECTION OF NON-FEDERAL DAMS  
BERRY POND DAM (NH 00.) (U) CORPS OF ENGINEERS WALTHAM  
MA NEW ENGLAND DIV AUG 78

BERRY POND DAM

NH 00105

PHASE I INSPECTION REPORT  
NATIONAL DAM INSPECTION PROGRAM

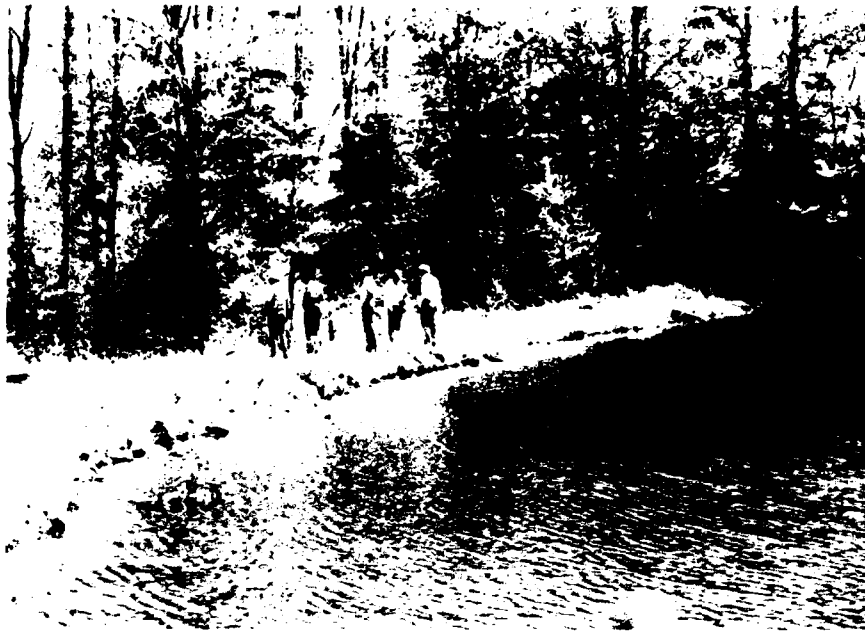
Overview from left abutment

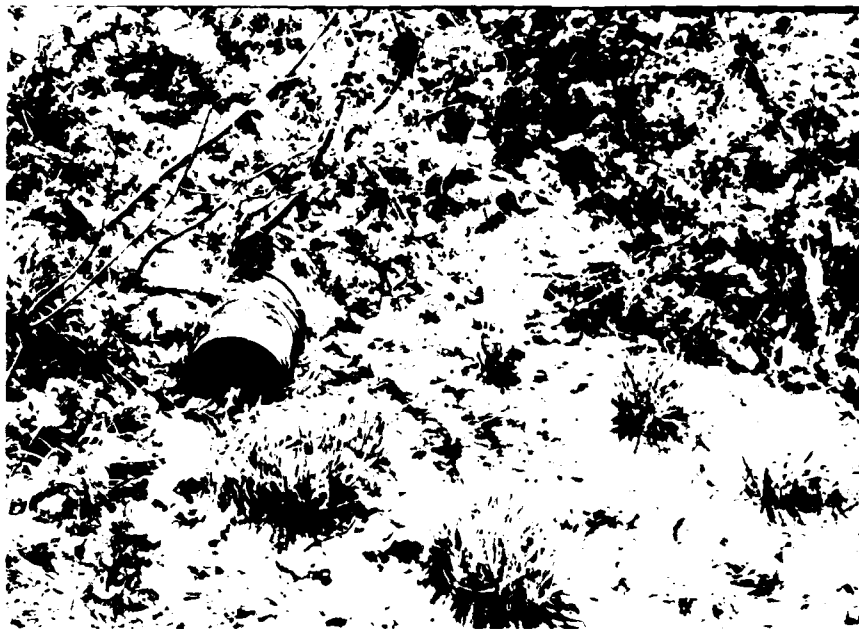
Two seepage areas were noted on the downstream slope of the earth dam. One seepage point is located 89 feet to the left of the concrete outlet box along the centerline of the earth embankment and approximately 25 feet downstream of and roughly 9 feet lower in elevation than the crest of the earth dam. Seepage was estimated at less than 0.05 gpm. A second seepage point was noted on the right abutment where the 10-inch outlet pipe exits on the slope. The seepage on the outside of the pipe is rust-colored and is estimated as less than 0.1 gallons per minute. It is understood that this outlet pipe has been plugged with concrete at its upstream end.

1. Seepage alongside abandoned outlet pipe looking downstream
